Pop-Up Troubleshooting Guide

**Offered by
Signature Automotive Products**

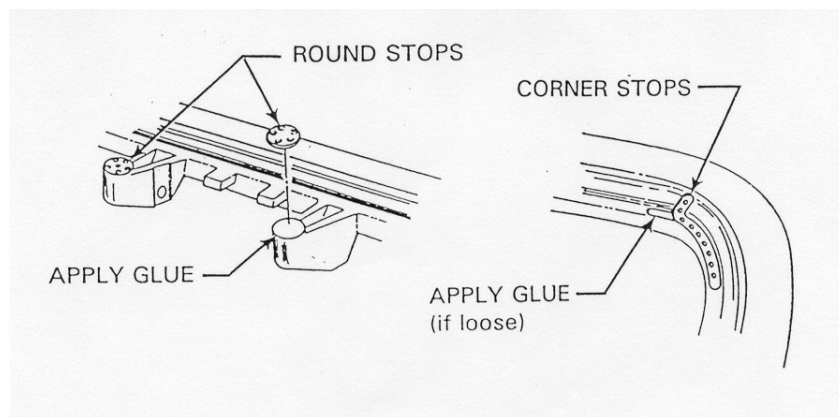
- 1) Check whether both front hinges are tight or whether one or both of them are loose. (Remove the glass panel and try to rotate the two metal hinges. You should not be able to move the hinges without applying force).
- 2) Check whether all the frame stoppers (round and straight) are still attached to the top frame. (Each roof has 6 frame stoppers attached. One stopper in each corner and one stopper directly in the front and the rear of the top frame).

- 2) Missing stoppers will always create a leak since the glass is not seating properly (bad contact with the seal and frame). This condition may also cause wind noise. Identify which stopper is missing and reattach with super glue.

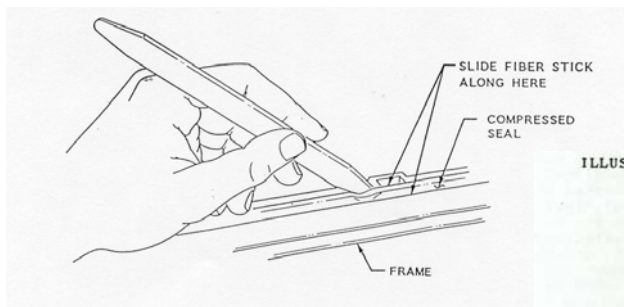
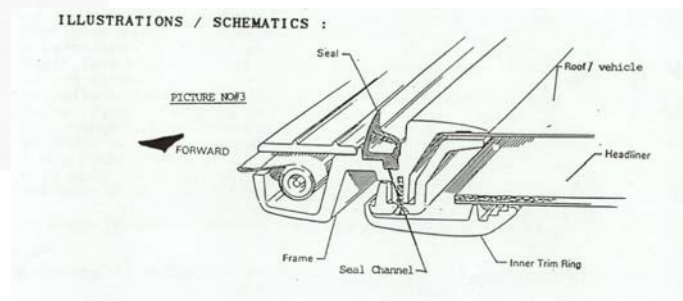
- 4) If you observe any skipping while cranking the handle, the entire top frame must be replaced.

- 1) Remove the glass panel and store the glass in a safe and secure place.
 - 2) Run a hook tool into the groove between the seal & frame. This should help you to separate the seal from the frame. Note: try to avoid any damage to the old seal. The goal is to remove the old seal from the seal channel in one piece.

- 3) Hold on to a portion of the seal and pull the seal out of the frame groove. Pull evenly, which avoids rupture of the old seal.
 - 4) Clean the seal channel (frame groove) with a scrape tool and assure that all the major silicon particles have been removed from the groove. (The seal channel should be reasonably clean – small silicon residue may be neglected and will not create problems)

- 5) Apply an even bead of fast curing silicon to the bottom part of the groove ($1/8^{\text{th}}$ of an inch).
 - 6) Insert the fresh main seal into the seal channel of the frame. Start with the center of the frame (opposite to the handle) and make certain that the two small holes in the seal are pointing towards the handle section. Apply light but consistent pressure while inserting the seal and assure that the seal stem slides fully into the designed channel.

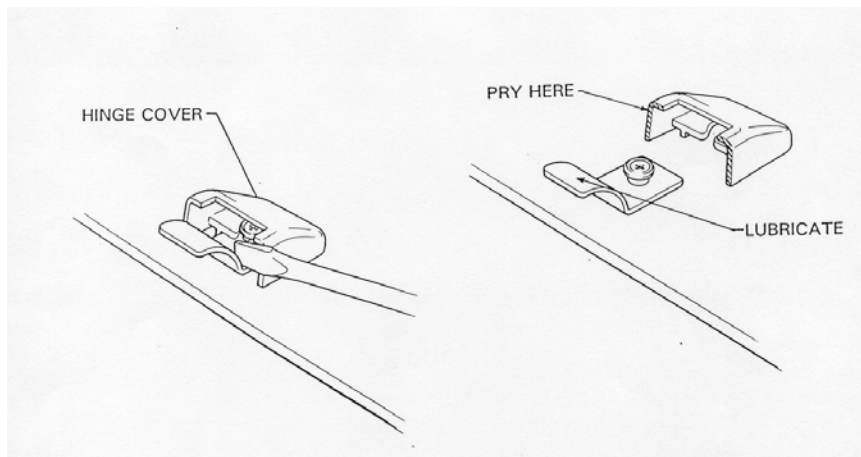
- 1) Noise originating from the hinge area.
- 2) Noise originating from the front of the frame.
- 3) Appears to originate in various areas of the roof while driving.

- A) The plastic hinge covers rubbing against the frame may generate noise at the hinge area. Remove the hinge covers and file the components down on the front (where they point towards the frame) approximately 1/16 of an inch. Re-attach the hinge covers and verify that the required clearance between the components and the frame is created. In case there is ample clearance between the frame and the hinge covers but the noise is still originating from the hinges, lubricate the hinges with spray lubricant or other available clear grease. (Differential oil 90WT also seems to work very well). Reinsert the glass panel with the lubricated hinges.

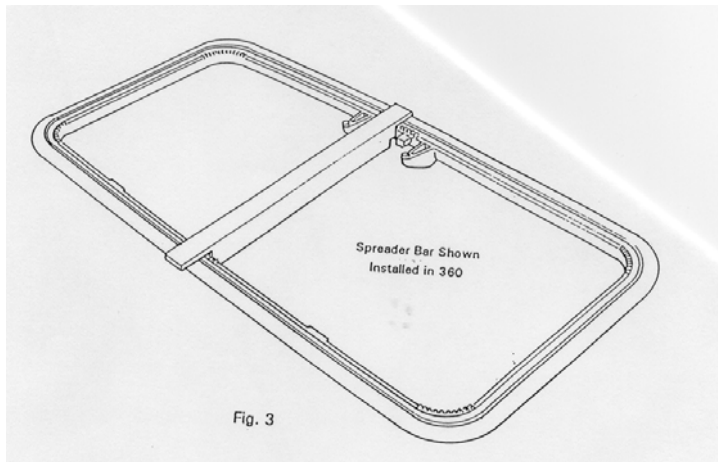
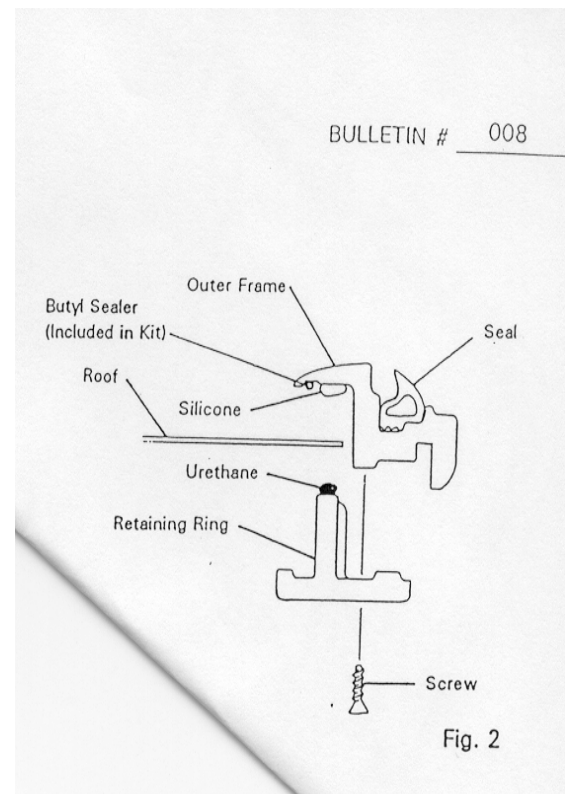
- B) Noise created at the front section of the frame can also be a result of loose hinges. Without the firm attachment of the glass to the frame via the tight fitted hinges, the panel might shift and rub against the frame that may create a certain noise. Also examine the clearance between the glass panel and the front of the frame. With the hinges firmly attached, the glass panel can rub against the frame provided the gap between the glass and the frame does not allow for the required clearance. This condition could be caused by installations of sunroofs in vehicles with extreme surface sweep of the vehicle roof. This adverse condition could even get worse in situations where the sunroof was installed with the glass panel already attached to the frame while the installer was tightening the screws. In certain vehicles with extreme sweep of the roof, this procedure could narrow the gap between the glass and frame even more and might result in a rubbing noise. If that is the case, remove the glass panel and unscrew the frame. Remove the top frame and insert a spacer bar into the top frame center section to keep the frame from moving with the glass. Re-attach the top frame to vehicle roof using silicon instead of butyl. Tighten the frame screws with the spacer bar still in place. After the silicon has hardened, remove the spacer bar and insert glass panel. In very rare and isolated applications, the bottom frame must be glued to the vehicle roof inside with silicon (as described in the top frame scenario). This creates a good connection between frame and vehicle and does not allow any further shifting of the sunroof

when the vehicle body is moving and shifting. Similar disturbances can be observed when the sunroof rubs against the vehicles' roof skin along the cut line as a result of the cut hole being too small. Always allow for ample clearance around the frame to avoid this installation problem.
